DOT/FAA/TC-17/63

Round Robin Evaluation of CACRC Bonded Repairs

November 2017

Final Report

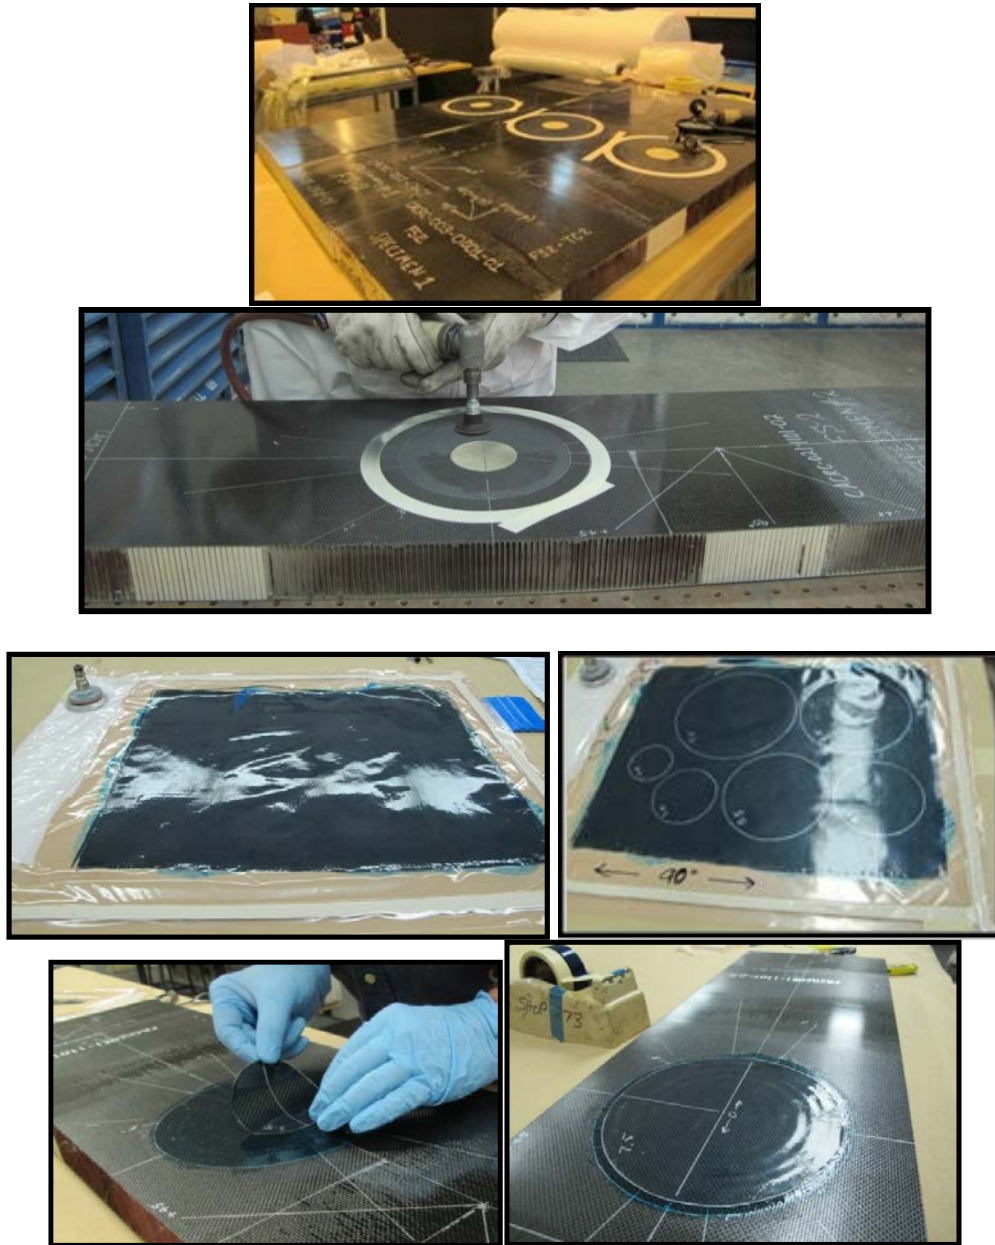
Figure 26. CACRC wet lay-up repair conducted at depot 1

Figures 26–30 show the repairs conducted at the various depots. Figure 26 provides an overview of a wet lay-up repair conducted at depot 1 following the same procedure provided to all depots. The figure shows the scarfing process, the wet lay-up repair ply impregnation, and lay-up.

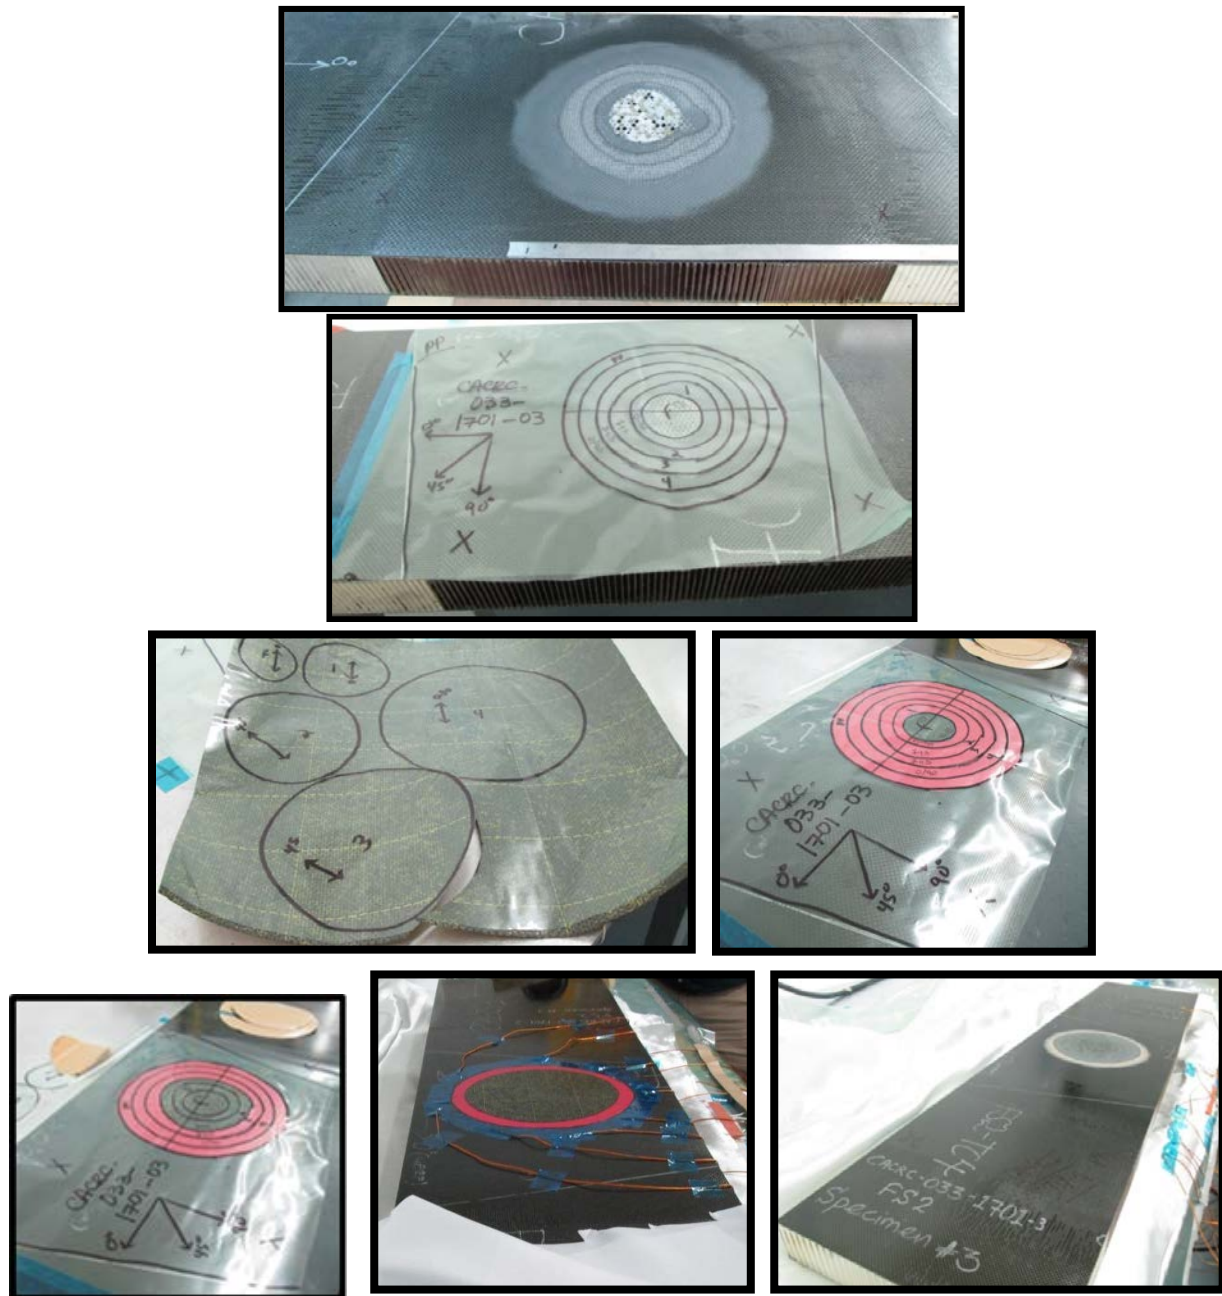
Figure 27. CACRC prepreg repair conducted at depot 2

Figure 27 provides an overview of a prepreg repair conducted at depot 2 following the same procedure provided to all depots. The figure shows the scarfing process, the prepreg repair ply preparation, cutting, repair, and the final cured prepreg repair. It should be noted that the first ply was over-sanded during the scarfing process, as shown in the figure. This exemplifies realistic

damage scenarios that may occur during damage removal and parent substrate scarfing, regardless of the level of training or competency of the repair technician performing the composite repair.

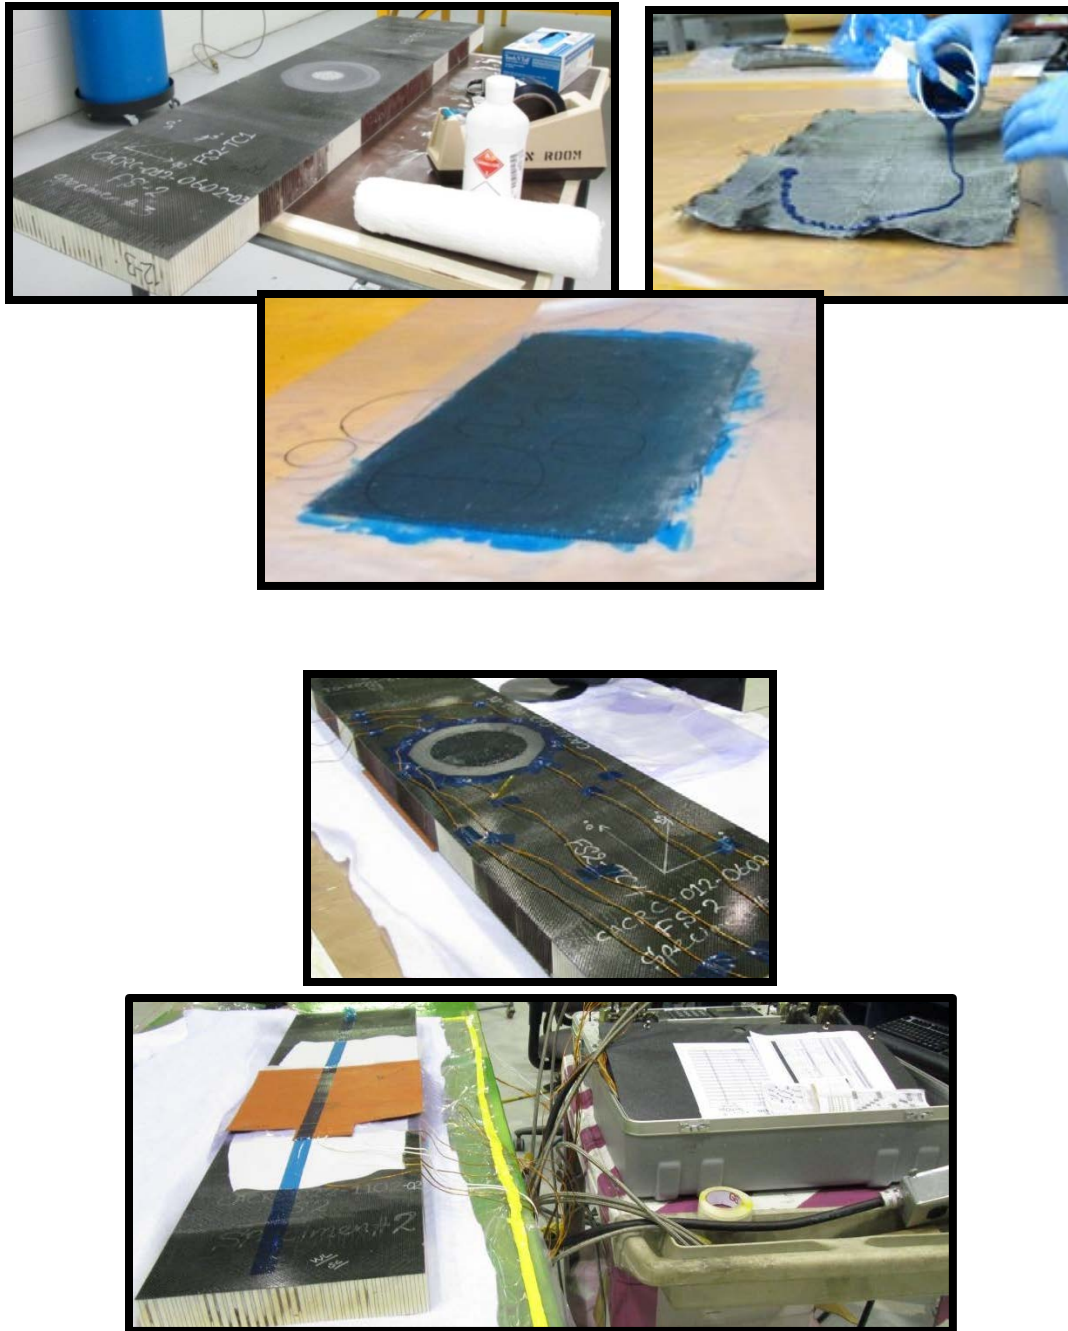
Figure 28. CACRC wet lay-up repairs conducted at depot 3

Figure 28 provides an overview of a wet lay-up repair conducted at depot 3 following the same procedure provided to all depots. The figure shows the scarfing process, the wet lay-up repair ply impregnation and lay-up, and the heat-blanket application in preparation for curing.

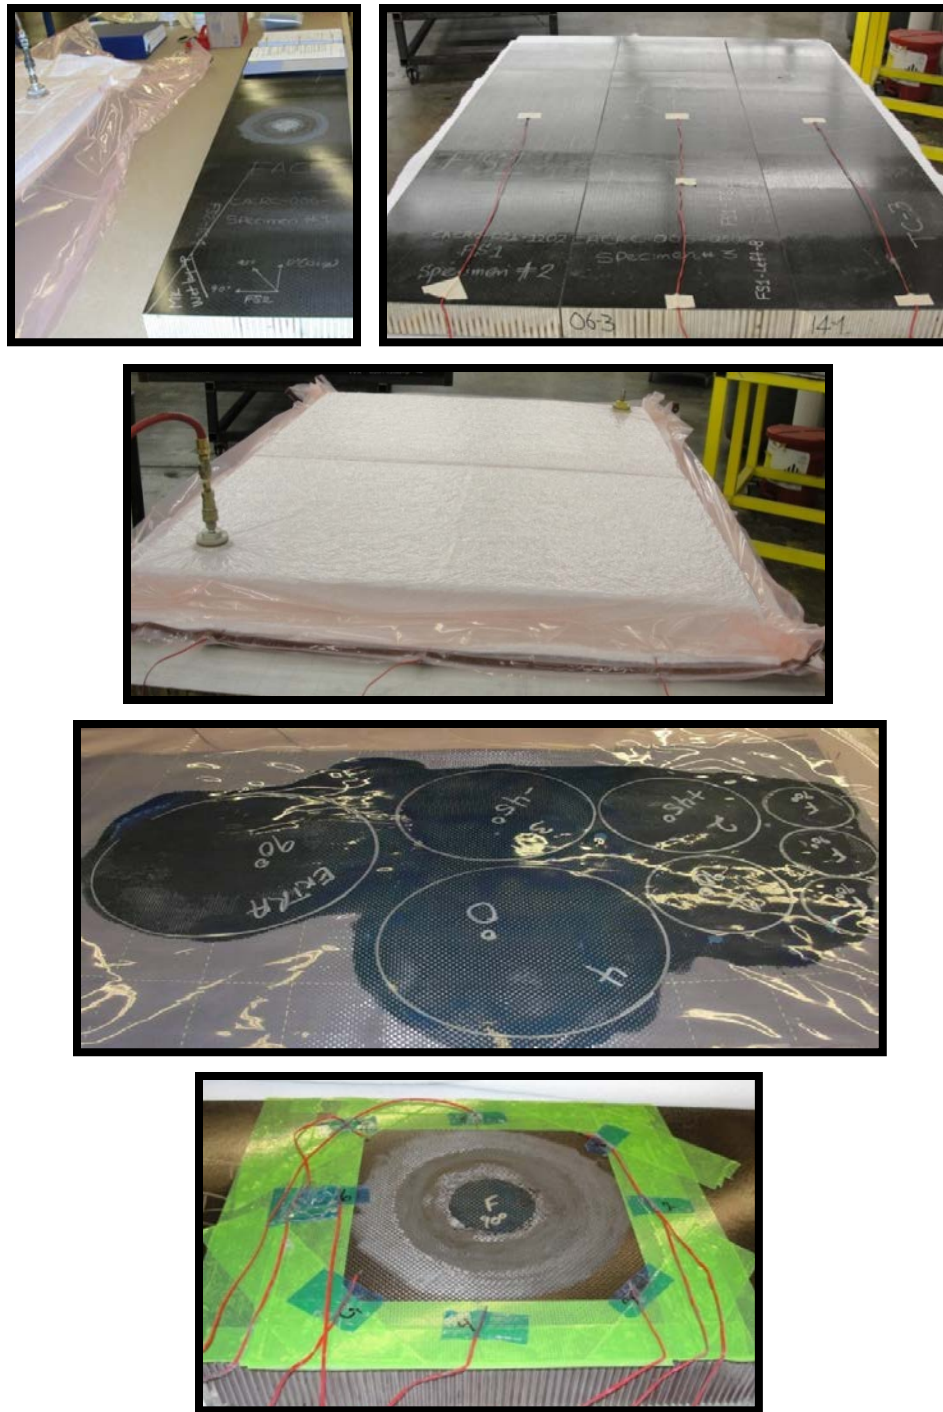
Figure 29. CACRC wet lay-up repairs conducted at depot 4

Figure 29 provides an overview of a wet lay-up repair conducted at depot 4 following the same procedure provided to all depots. The figure shows the scarfing process, the panel drying prior to repair, and the wet lay-up repair ply impregnation and lay-up.

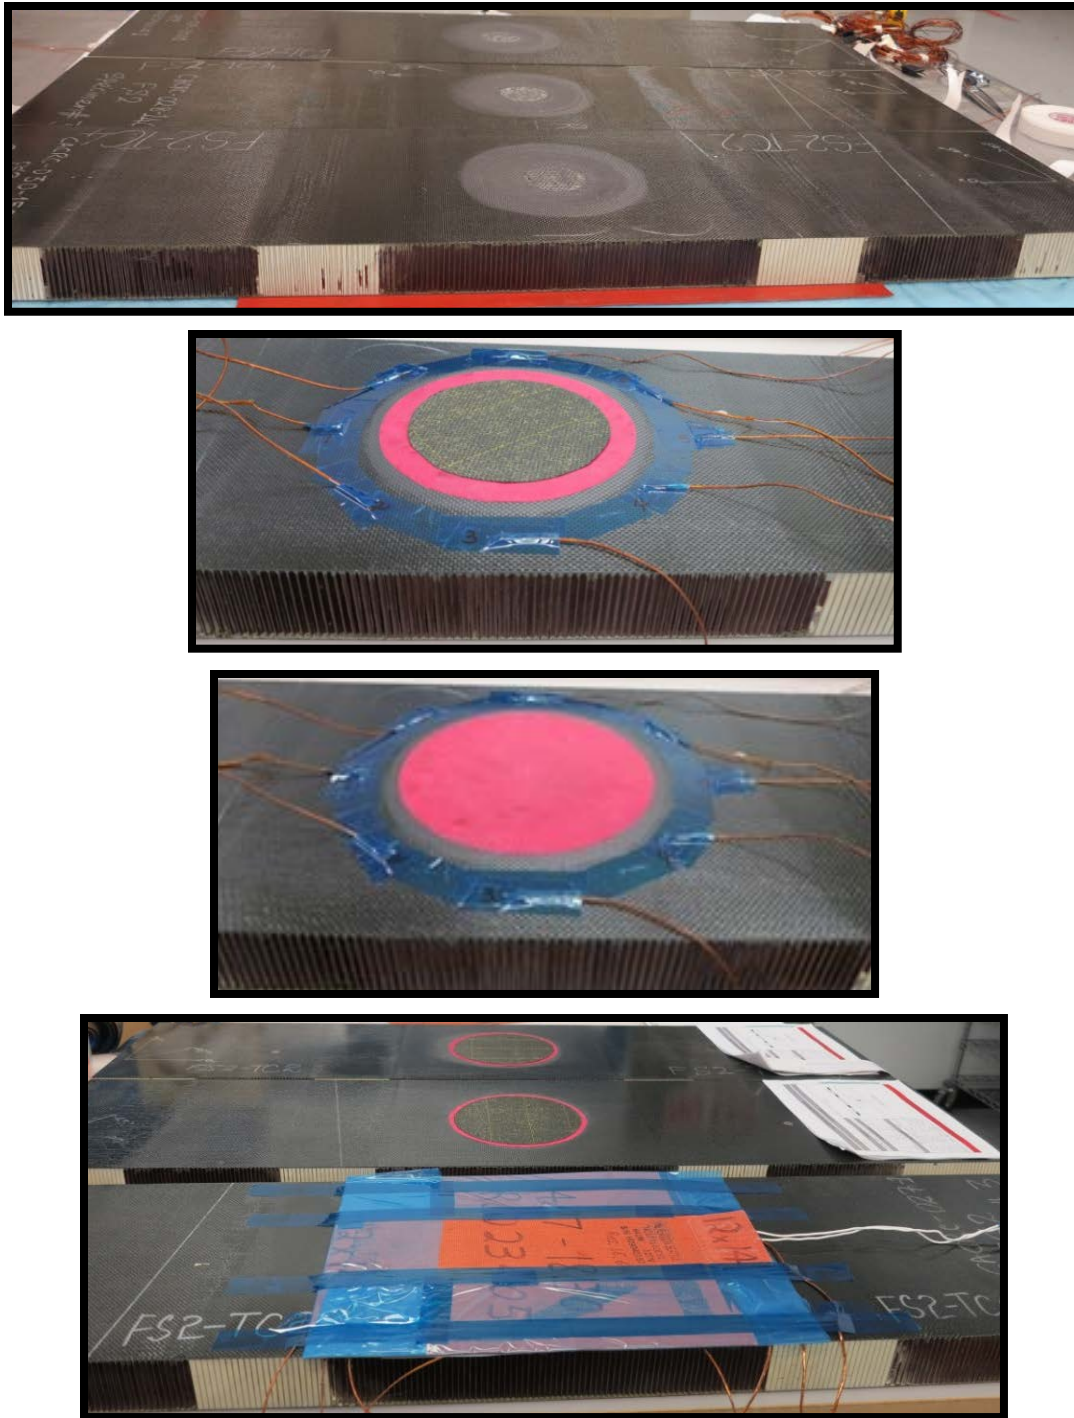
Figure 30. CACRC prepreg repairs conducted at depot 5

Figure 30 provides an overview of prepreg repairs conducted at depot 5 following the same procedure provided to all depots. The figure shows the scarfing process, the repair lay-up, and heat-blanket application prior to cure.

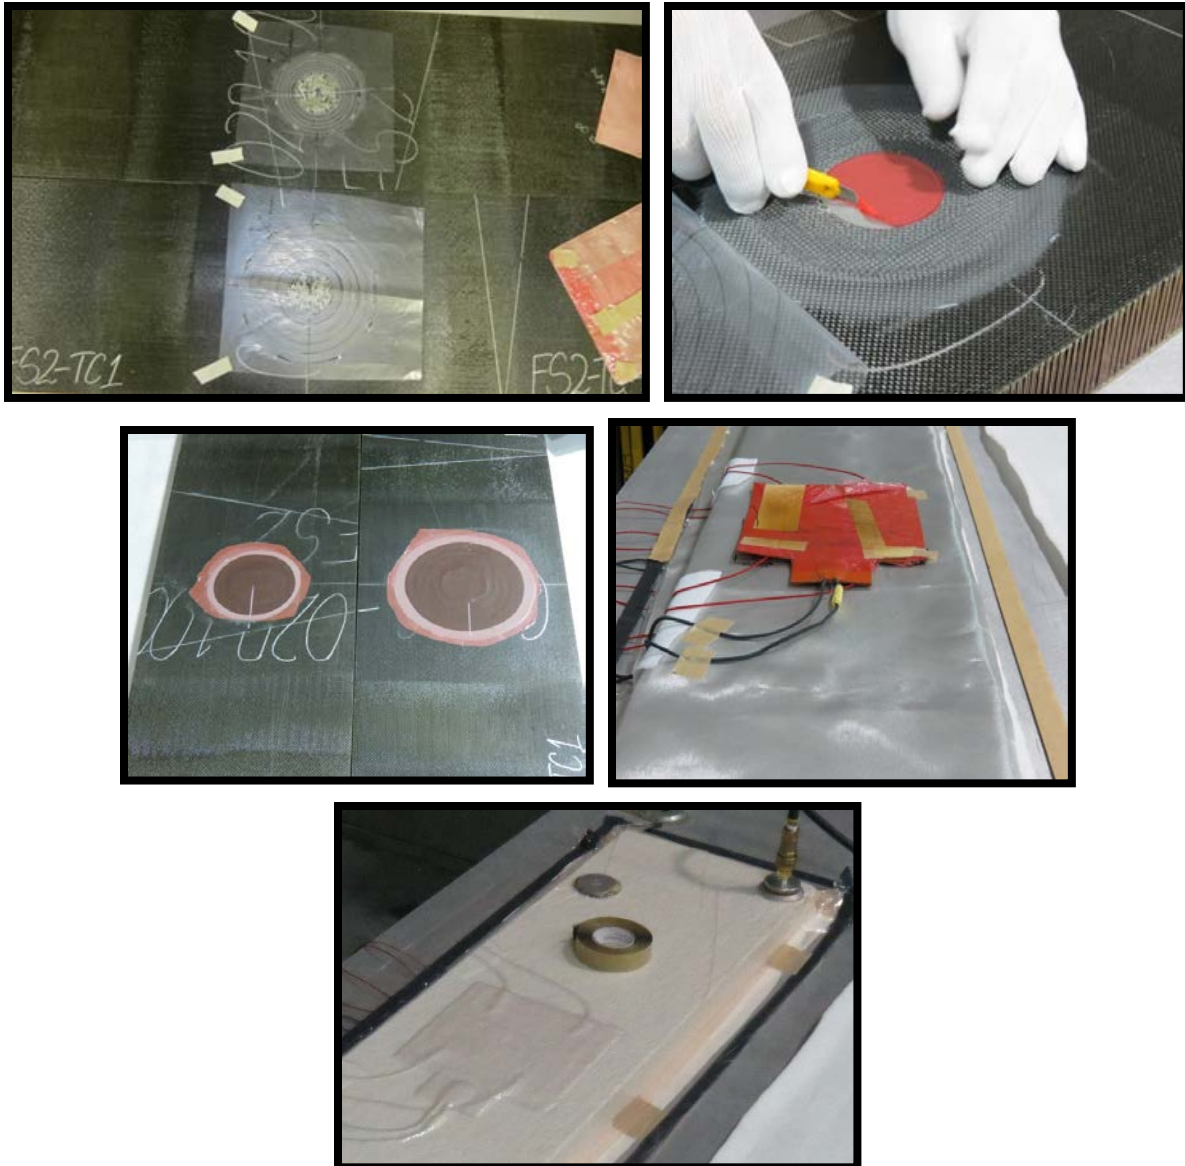
Figure 31. OEM prepreg repairs (conducted at the OEM factory)

Figure 31 provides an overview of OEM prepreg repairs conducted at the OEM factory using the OEM materials and a proprietary process for repair application. The figure shows scarfed panels with two different scarf overlaps: a 0.25-inch overlap and a 0.5-inch overlap, with Mylar templates showing the outline of the repair plies. The figure also shows the adhesive and repair application, heat-blanket application, and final repair bagging.

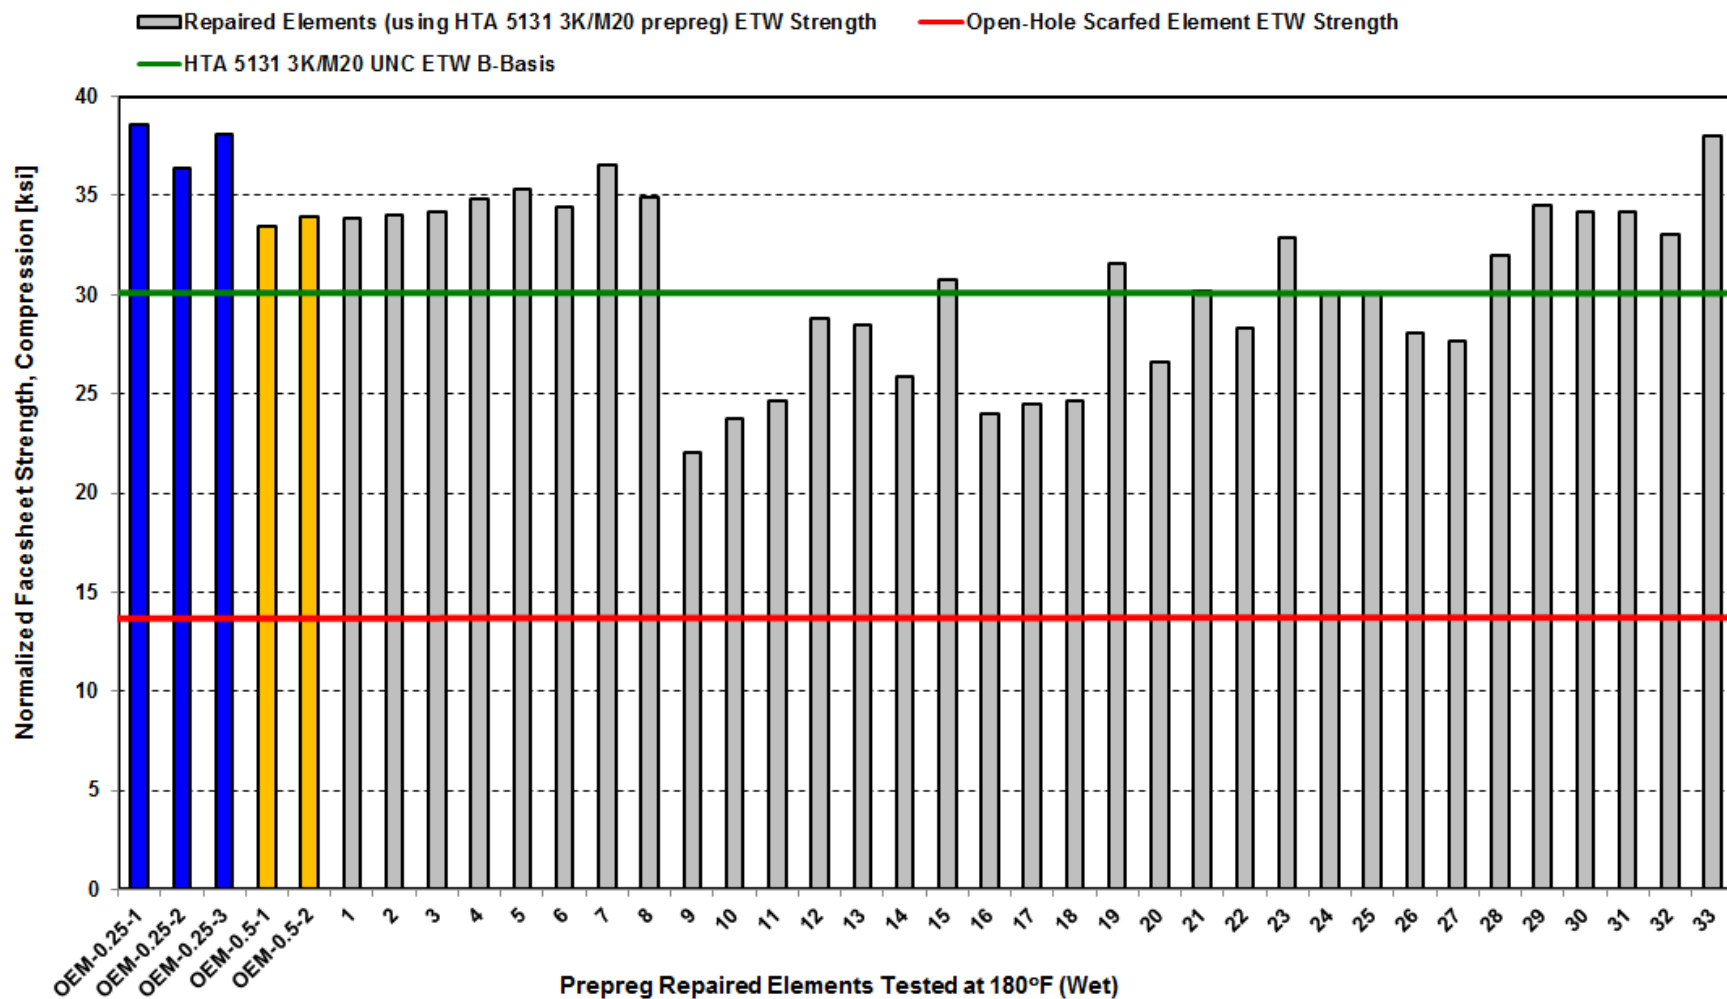
Figure 40. Round robin compression test results for all prepeg repairs tested at 180°F wet

Round robin strength results for all elements repaired using M20 PW and EA9695 adhesive tested with the repair in compression at 180°F wet are summarized in figure 40. Individual facesheet normalized strength values for all the repair elements tested with the repair in compression are plotted in the figure. Thirty-three data points (instead of 39) are plotted. Five repairs from two depots were not completed and one element was damaged during testing. The repair data are normalized using a 0.0083-inch cured ply thickness. The repair elements tested at 180°F yielded an average ETW strength of 30.5 ksi (Min=22.1 ksi, Max=38.0 ksi). The baseline/undamaged elements tested at 180°F yielded an average ETW strength of 35.4 ksi (Min=32.9 ksi, Max=38.2 ksi). The repair strength values are compared to unrepaired open-hole scarf elements' average strength of 13.7 ksi (simulating a failed patch/repair condition). These values are also compared to the repair laminate open-hole and unnotched compression ETW B-basis values of 24 ksi and 30.1 ksi, respectively.

Sixty-one percent of all repair elements restored yielded strength values greater or equal to the ETW B-basis unnotched compression of the repaired laminate. Eighty-two percent of all repair elements yielded strength values higher than the ETW B-basis open-hole compression strength of the repaired laminate. Post-test analysis was conducted on all understrength repairs to identify root causes for the lower residual strength values. Round robin strength results for elements repaired with CACRC materials using M20 PW and EA9695 adhesive and elements repaired with OEM prepreg materials tested with the repair in compression at 180°F are summarized in figure 40. OEM-0.25-1, 2, 3 (blue columns in chart) were repaired at the OEM factory using the OEM-R1 prepreg material and a 0.25-inch scarf overlap. These repairs yielded the highest residual ETW average strength (37.7 ksi). OEM-0.5-1, 2, and 3 (yellow columns in chart) were repaired at the OEM factory using the OEM-R1 prepreg material and a 0.5-inch scarf overlap. These repairs yielded a residual ETW average strength of 33.7 ksi, comparable to that of the elements repaired with the CACRC prepreg material (columns in grey).

It should be noted that all CACRC prepreg repairs, including the six understrength repairs identified as elements 9, 10, 11, 16, 17, and 18 in figure 40 yielded facesheet compression failures either through the repairs or in the parent, all within the gauge section. None of the CACRC prepreg repairs yielded adhesion failures. All understrength repairs failed in the repair gauge section in the facesheet through the repair.

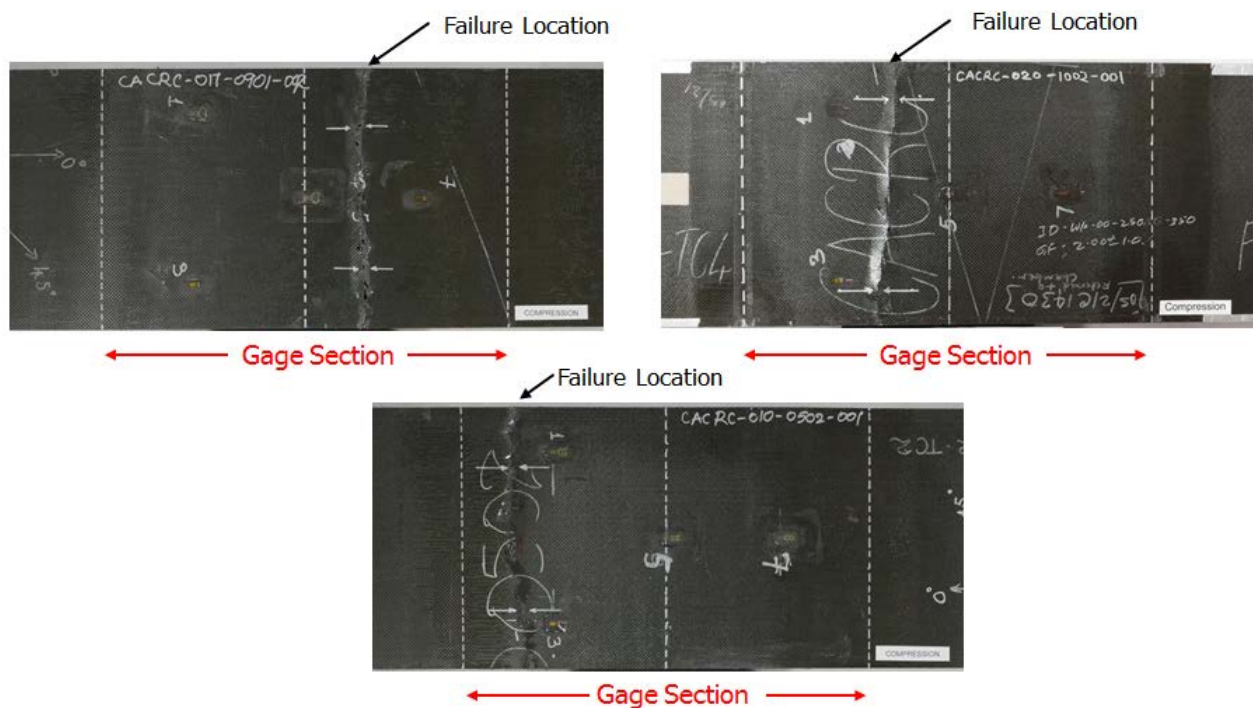
Figure 41. Representative failure modes of baseline/undamaged elements tested at 180°F

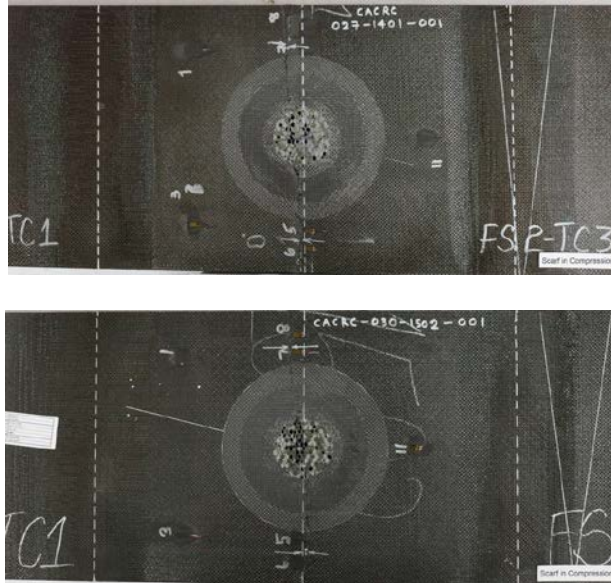
Figure 42. Representative failure modes of open-hole scarfed elements (unrepaired) tested at 180°F (this configuration simulates a patch-off/completely failed repair condition)

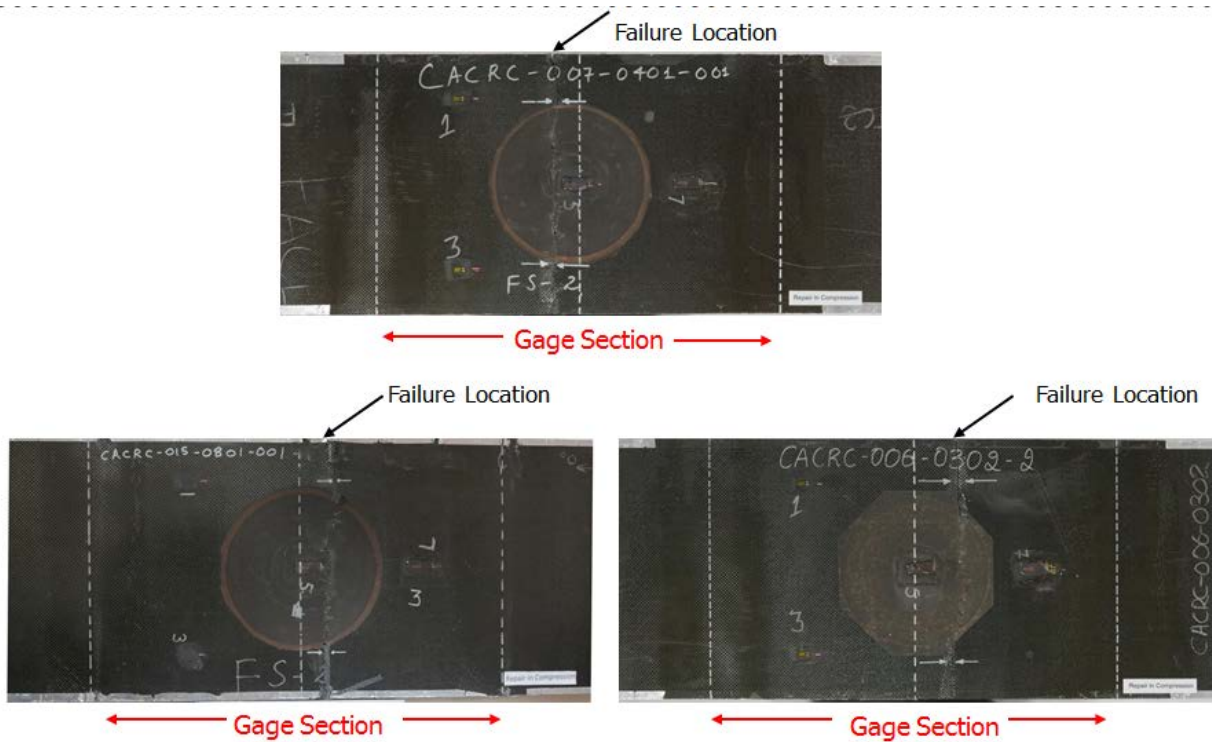
Figure 43. Representative failure modes of CACRC prepreg repairs using M20PW/EA9695 (facesheet compression failure through the repair)

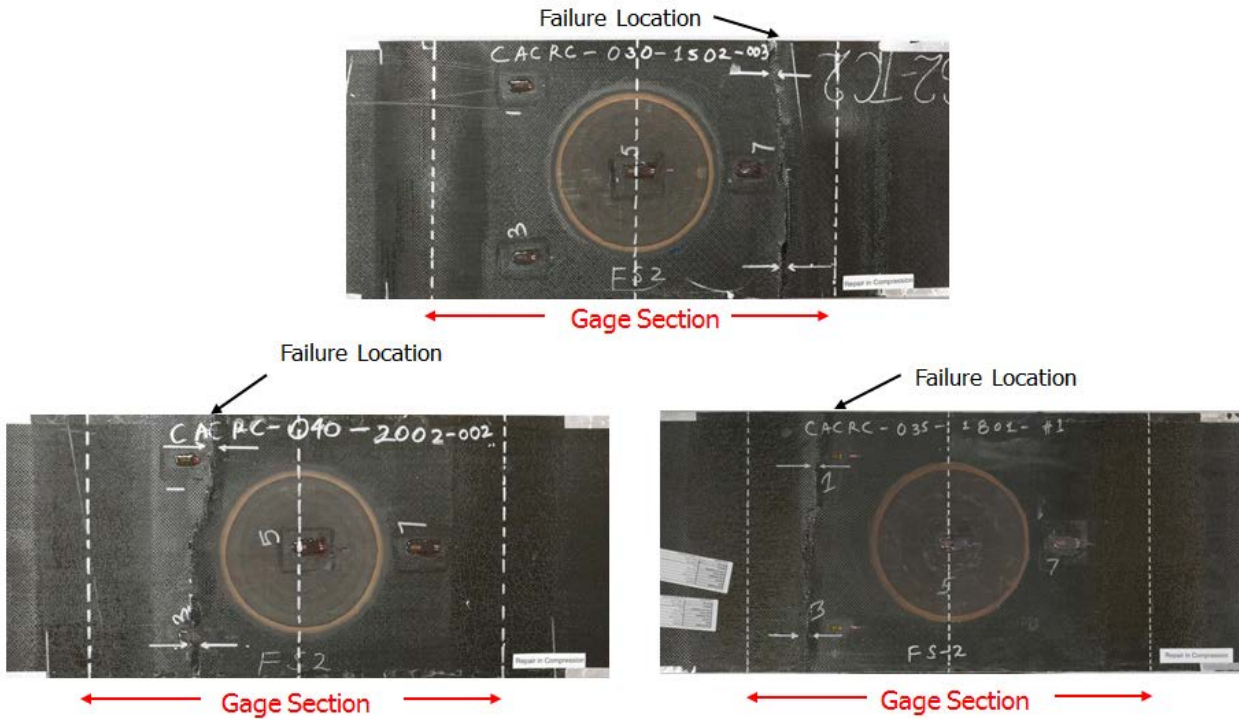
Figure 44. Representative failure modes of CACRC prepreg repairs using M20PW/EA9695 (facesheet compression failure outside the repair, through the parent)

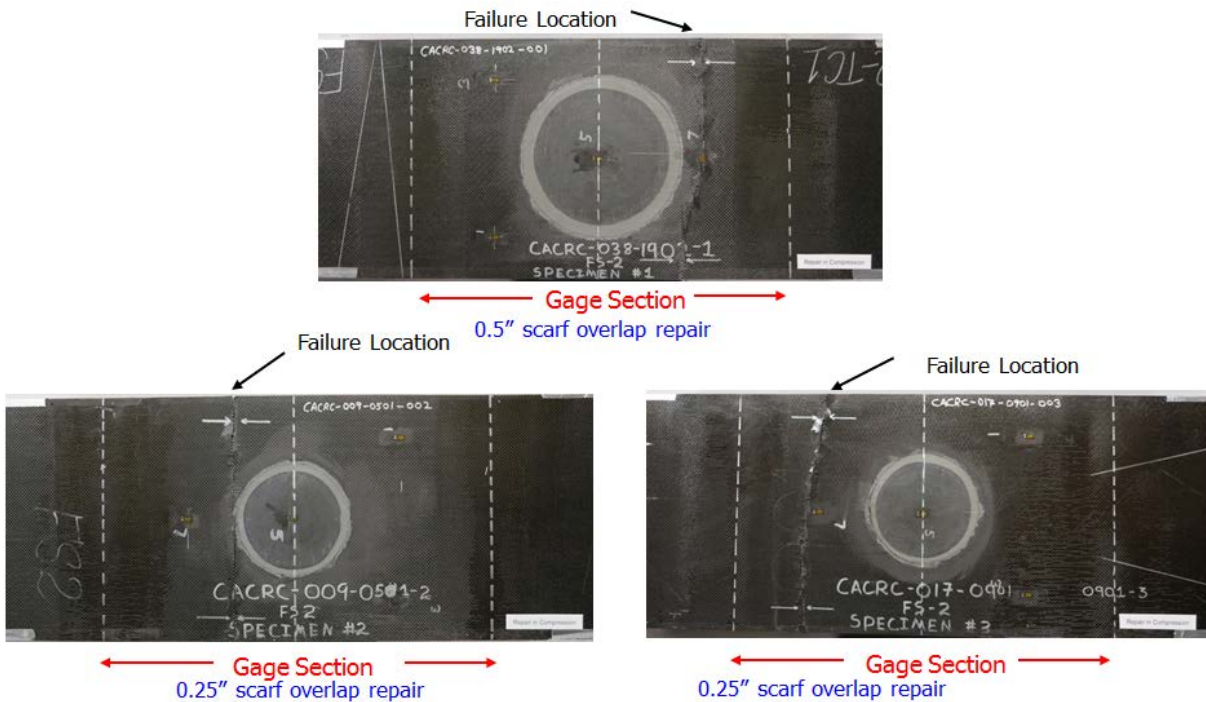
Figure 45. Representative failure modes of OEM-R1 prepreg repairs using T300/934 PW and FM377 adhesive (facesheet compression failure outside the repair, through the parent)

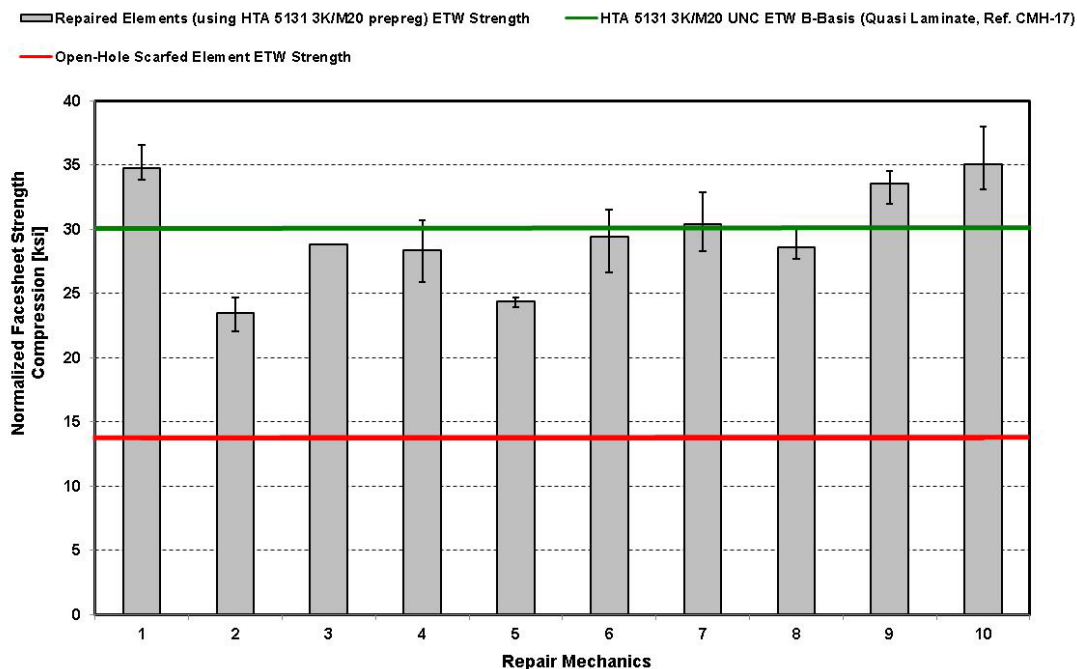
Figure 46. Round robin compression test results for CACRC prepreg repairs (M20 PW/ EA9695 adhesive tested at 180°F Wet) performed by different mechanics

Test results obtained from elements repaired using CACRC-R1 prepreg materials by different mechanics are summarized in figure 46. Mechanics 3, 5, 7, and 9 had minimal levels of experience, and all the other technicians were experienced. CACRC-R1 repairs were conducted using Hexcel M20/G904 prepreg and EA9695 NW adhesive (cured at 250°F) at five operator depots and at NIAR. The strength results summarized in figure 46 are repair average compression strength values from a minimum of three elements tested at ETW condition at 180°F. All mechanics performed a minimum of three prepreg repairs with the exception of mechanic 3 who performed only one repair. The repair strength values were compared to unrepaired open-hole scarf elements with an average strength of 13.7 ksi (simulating a failed patch/repair condition). These values are also compared to the repair laminate open-hole unnotched compression ETW B-basis values of 24 ksi and 30.1 ksi, respectively.

It should be noted that all six understrength repairs identified as elements 9, 10, 11, 16, 17, and 18 in figure 40 were performed by operators 2 (experienced) and 5 (minimal level of experience), respectively, as shown in figure 46. This demonstrates that repairmen experience alone is not a predictor of repair performance.

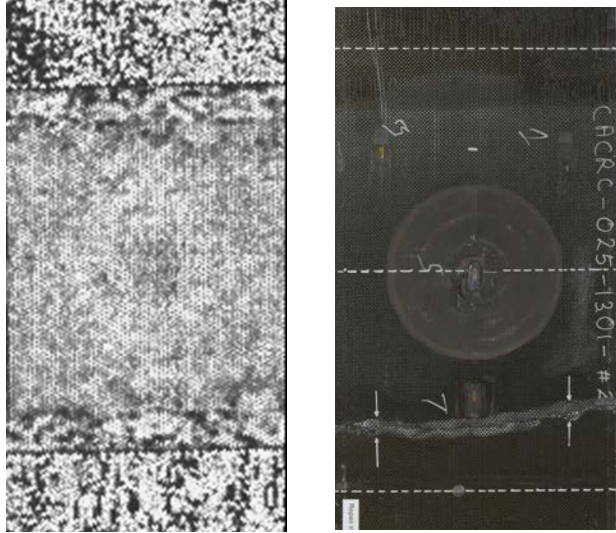
Figure 53. CACRC-025-1301-002-P-RC-ETW (element 5), TTU scan and post-test picture

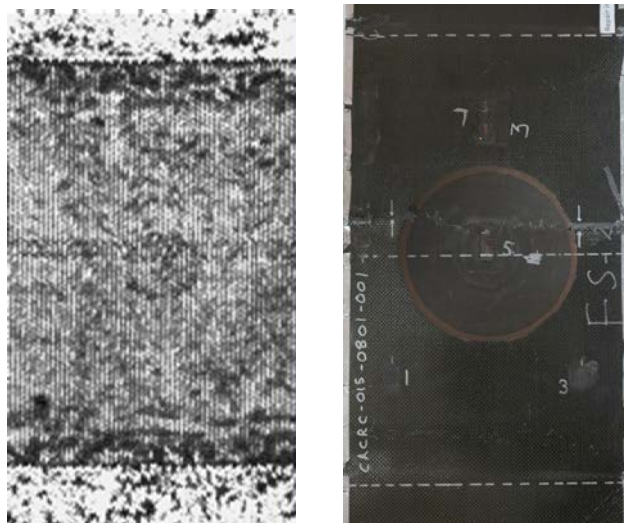
Figure 54. CACRC-015-0801-001-P-RC-ETWF (element 7), TTU scan, and post-test picture

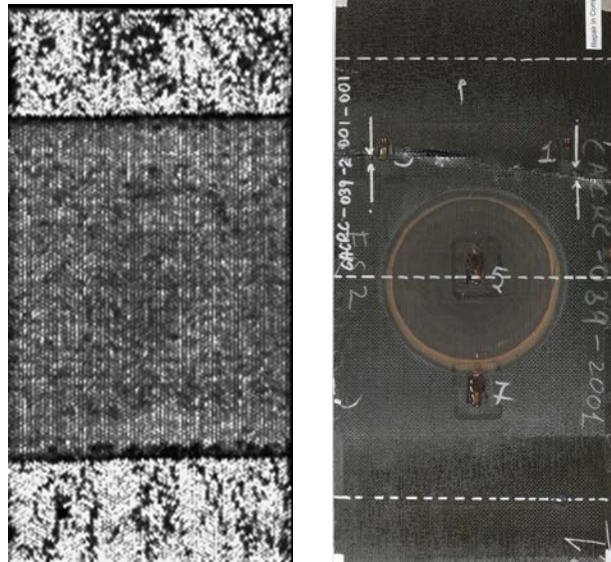
Figure 55. CACRC-039-2001-001-P-RC-ETW (element 33), TTU scan and post-test picture

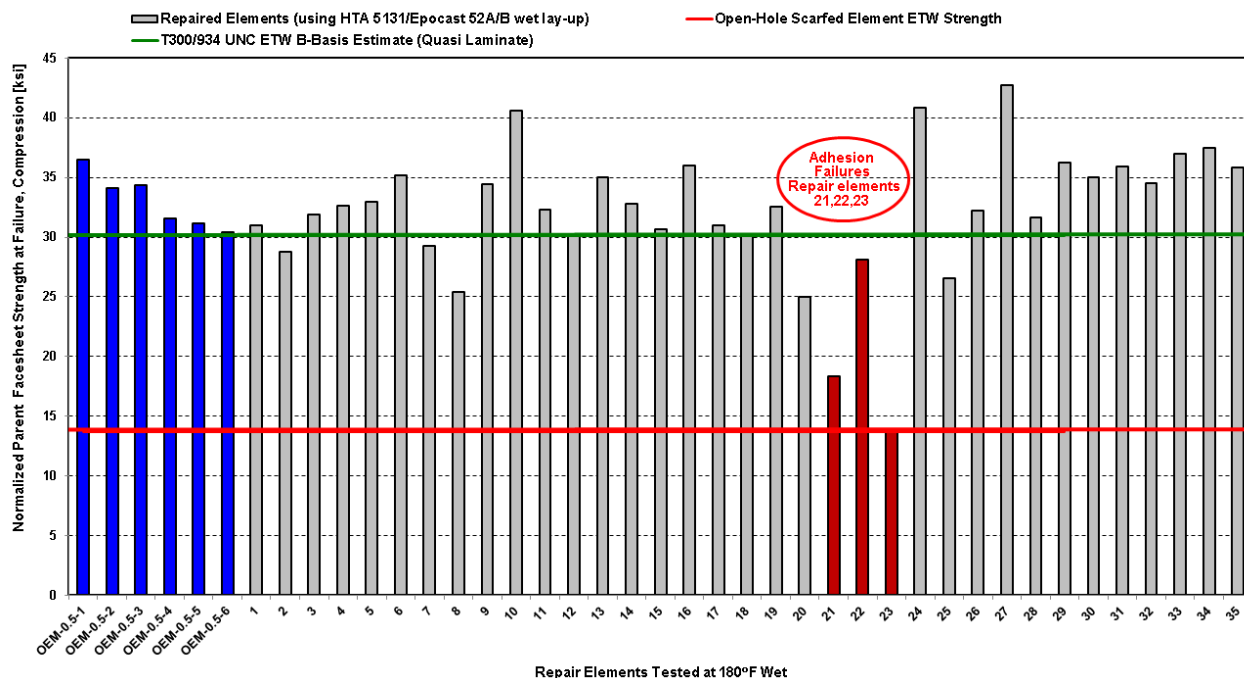
Figure 61. Round robin compression test results for all wet lay-up repairs tested at 180°F wet

Seventy-seven percent of all repair elements restored yielded strength values greater or equal to the ETW B-basis unnotched compression of the parent laminate. Post-test analysis was conducted on all understrength repairs to identify root causes to the lower residual strength values. Figure 61 also summarizes parent strength for repair elements using OEM wet lay-up materials tested with the repair in compression at 180°F. OEM-0.5-1, 2, 3, 4, 5, and 6 (blue columns in figure 61) were repaired at NIAR using the OEM-R2 wet lay-up material and a 0.5-inch scarf overlap. These repairs yielded higher residual ETW average parent facesheet strength (33.0 ksi) than the elements repaired with the CACRC-R2 wet lay-up material (columns in grey).

It should be noted that all CACRC wet lay-up repairs yielded facesheet compression failures, either through the repairs or in the parent, all within the gauge section, with the exception of elements 21, 22, and 23, which had adhesion failures in the repair. All OEM wet lay-up repairs yielded facesheet compression failures either in the parent or the repair.

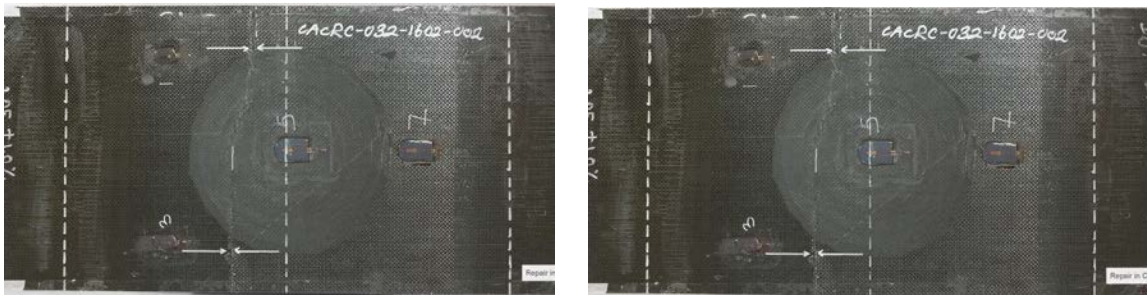
Figure 62. Representative failure modes of CACRC wet lay-up repairs using G904 D1070 TCT fabric with Epocast 52A/B (facesheet compression failure through the repair)

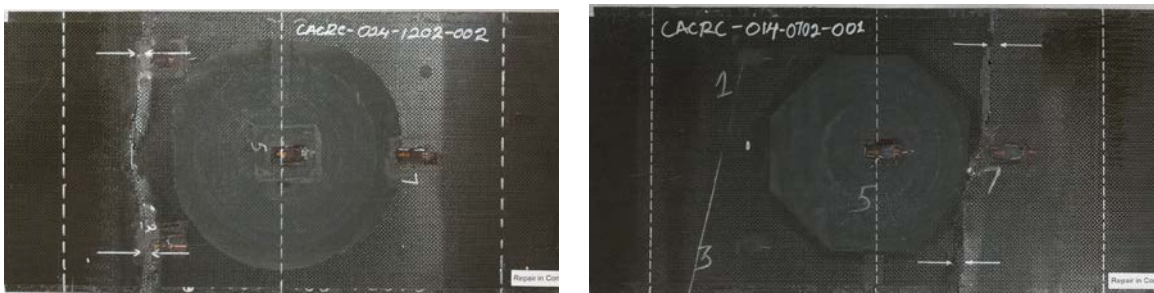
Figure 63. Representative failure modes of CACRC-R2 wet lay-up repairs using G904 D1070 TCT fabric with Epocast 52A/B (facesheet compression failure outside the repair, through the parent)

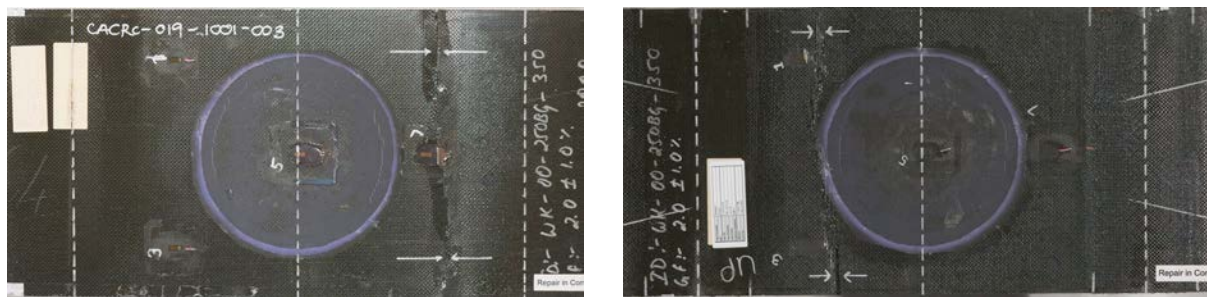
Figure 65. Representative failure modes of OEM-R2 wet lay-up repairs using T300 3K fabric, EA9396 C2 laminating resin, and EA9696 adhesive (facesheet compression failure outside the repair, through the parent)

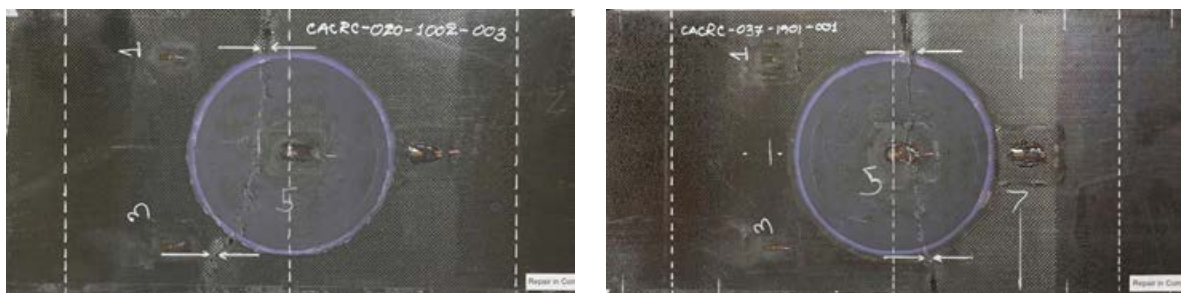
Figure 66. Representative failure modes of OEM-R2 wet lay-up repairs using T300 3K fabric, EA9396 C2 laminating resin, and EA9696 adhesive (facesheet compression failure through the repair)

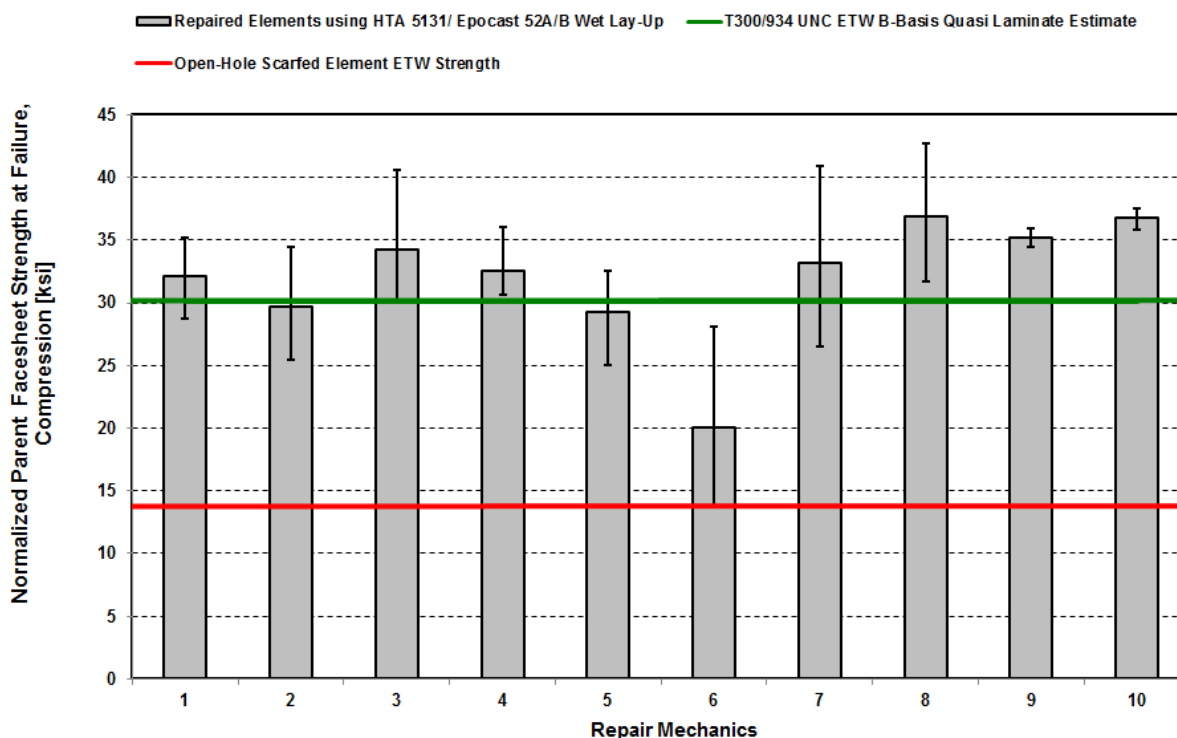
Figure 67. Round robin compression test results for CACRC wet lay-up repairs (tested at 180°F wet) performed by different mechanics

It should be noted that all three defective repairs yielding adhesion failures identified as elements 21, 22, and 23 in figure 61 were all performed by operator 6 (experienced), as shown in figure 67. This demonstrates that repair technician experience alone is not a sufficient predictor of repair performance.
